Docket No. SA-537

NATIONAL TRANSPORTATION SAFETY BOARD

Attachment 1 – Photographs

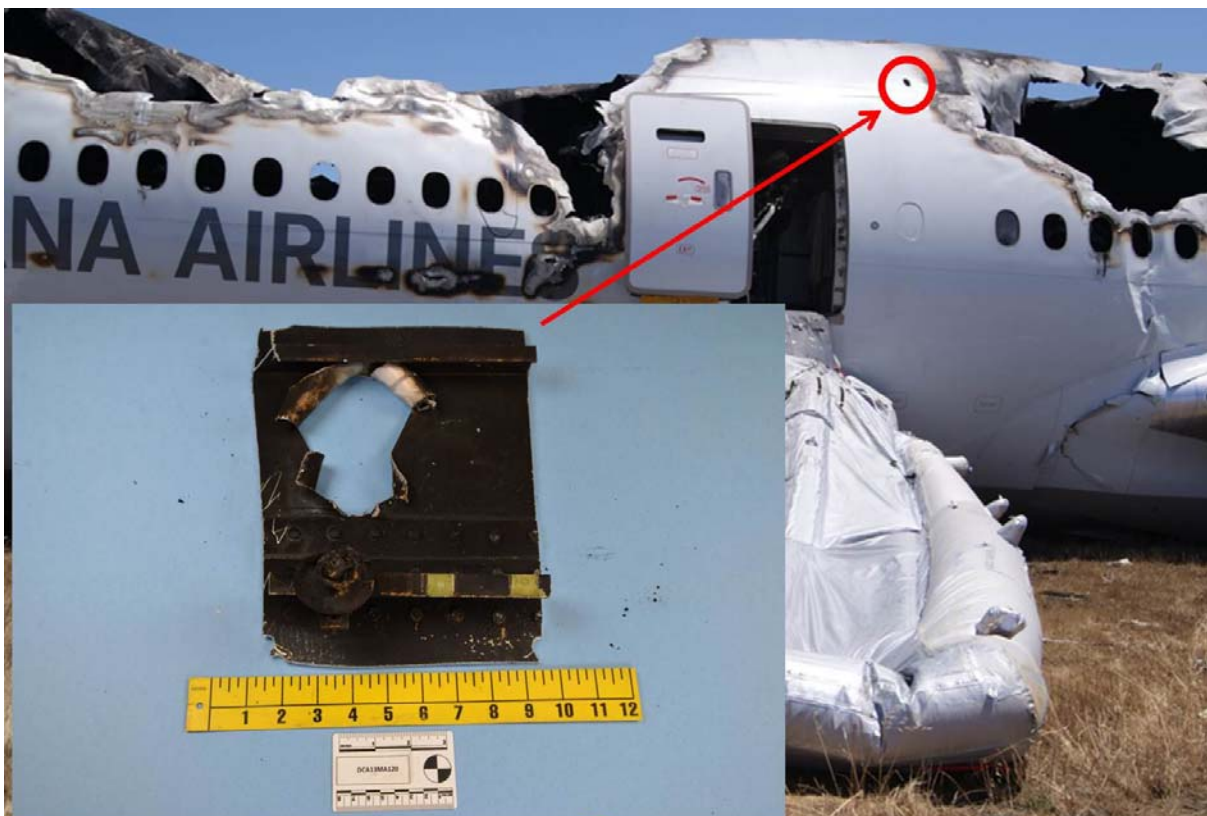
Photo 15. Snozzle penetration hole aft of door 2L.

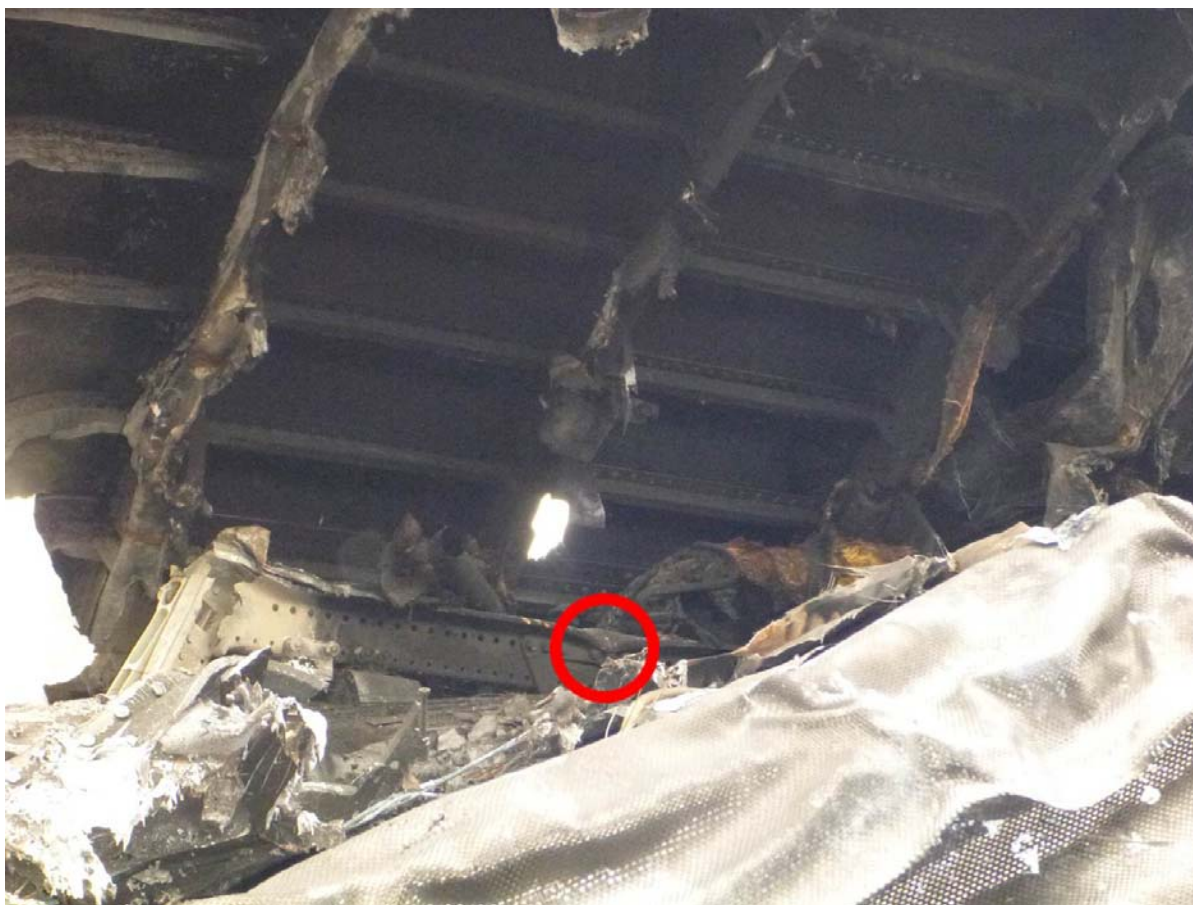
Photo 16. Damage to overhead bin support rail aft of door 2L.

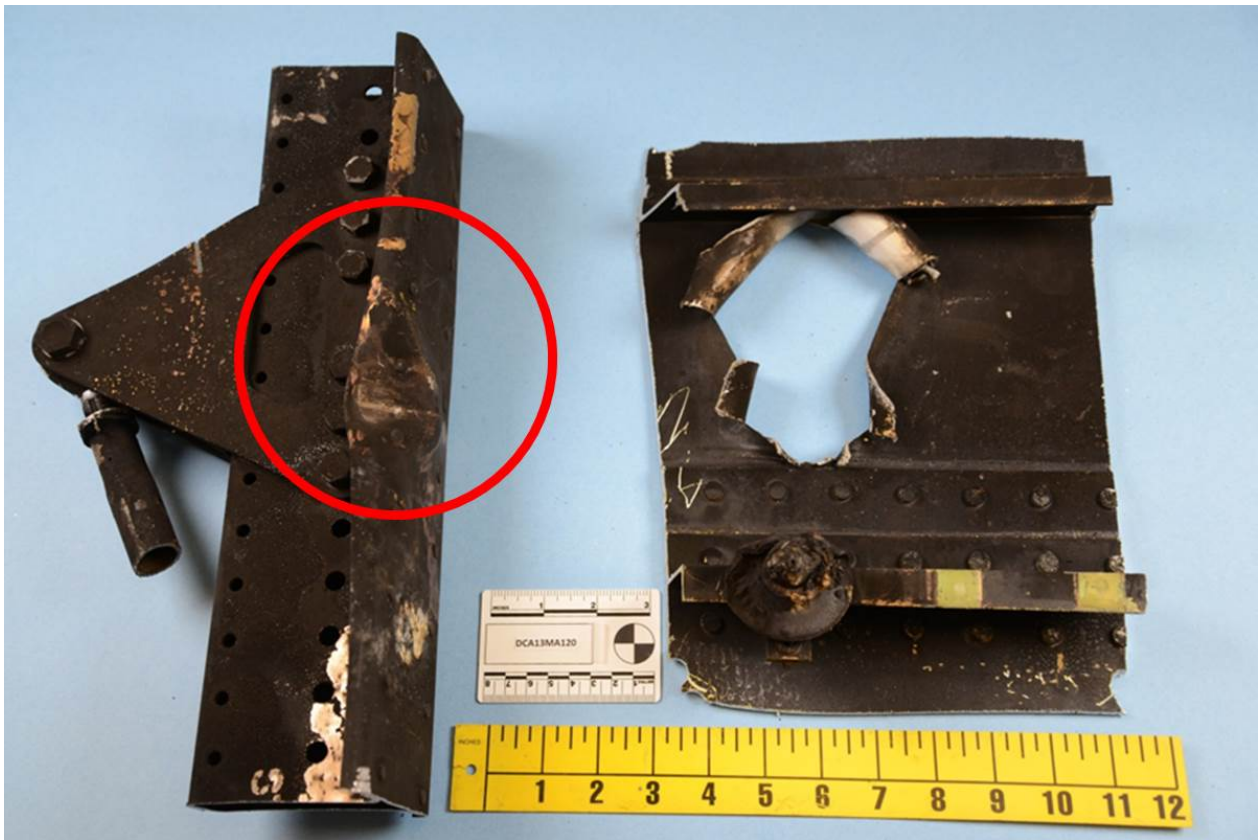
Photo 17. Damage to overhead bin support rail aft of door 2L.

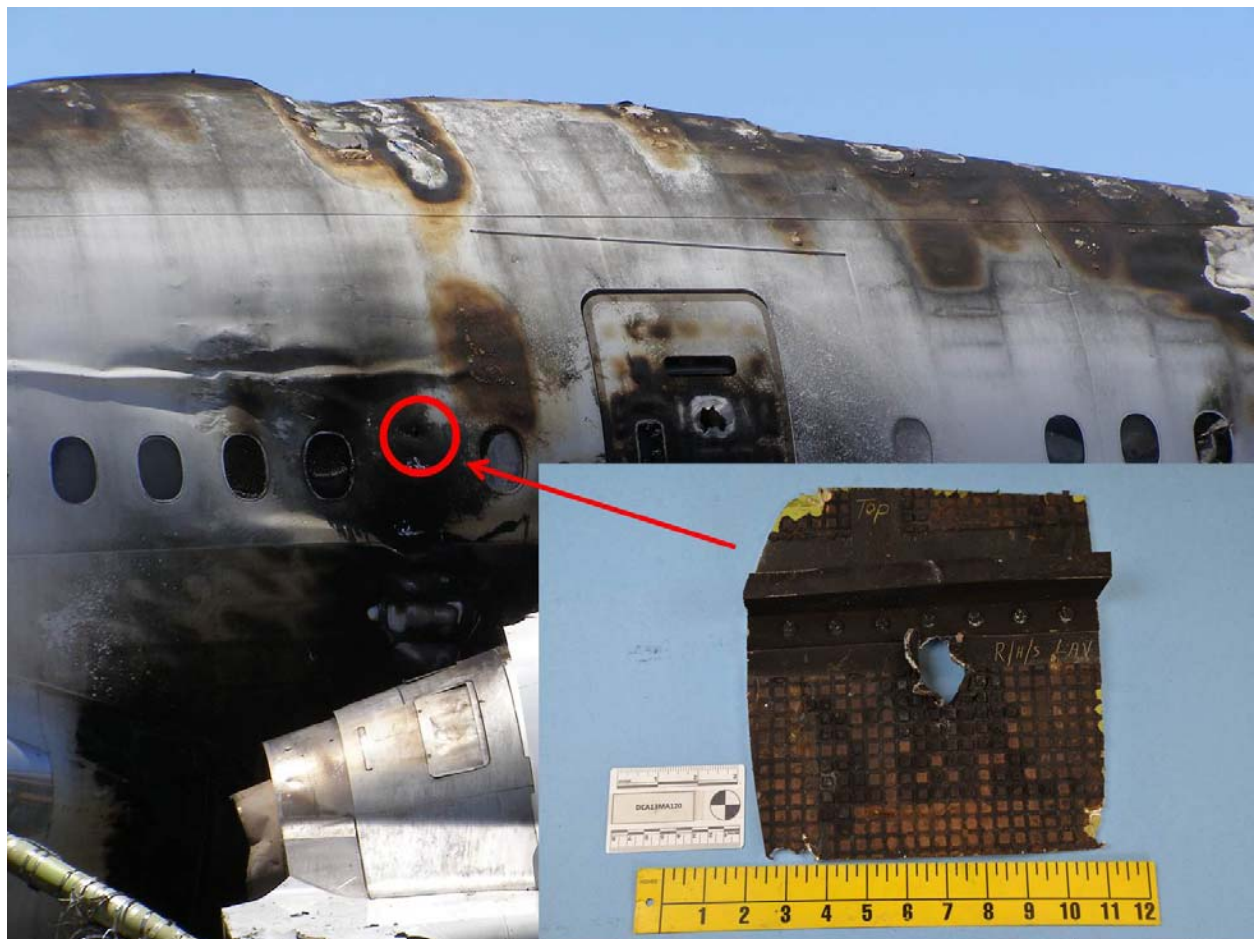
Photo 18. Snozzle penetration hole aft of door 2R.

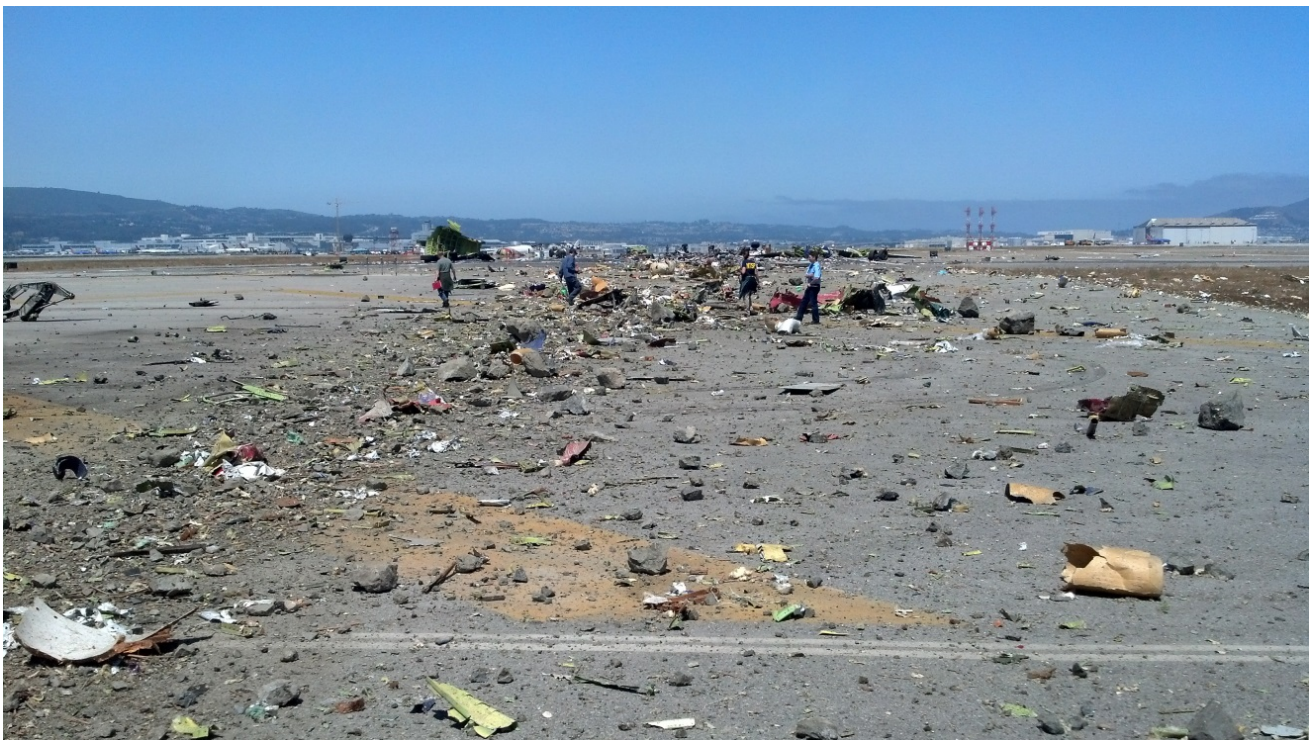
Photo 20. View of airplane debris from near the seawall.

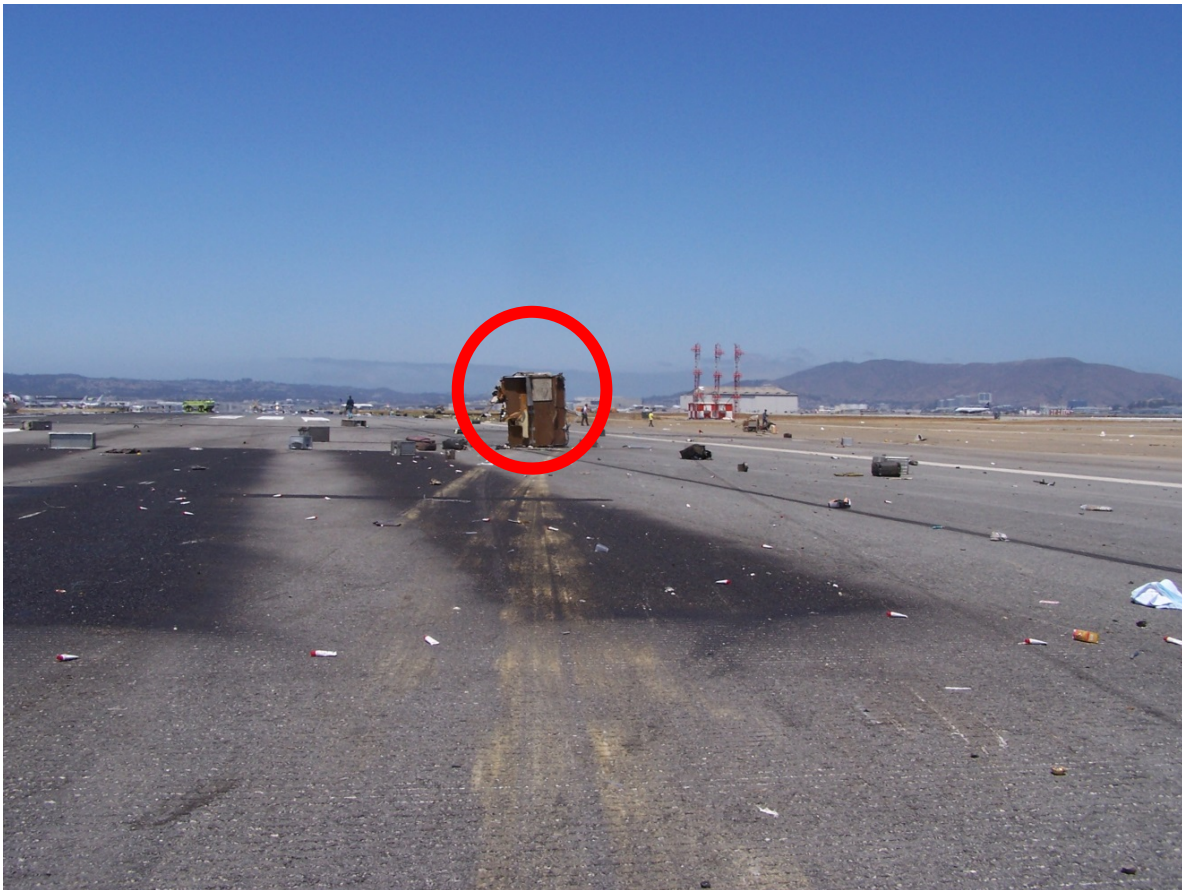
Photo 21. 4L jumpseat and aft galley structure.

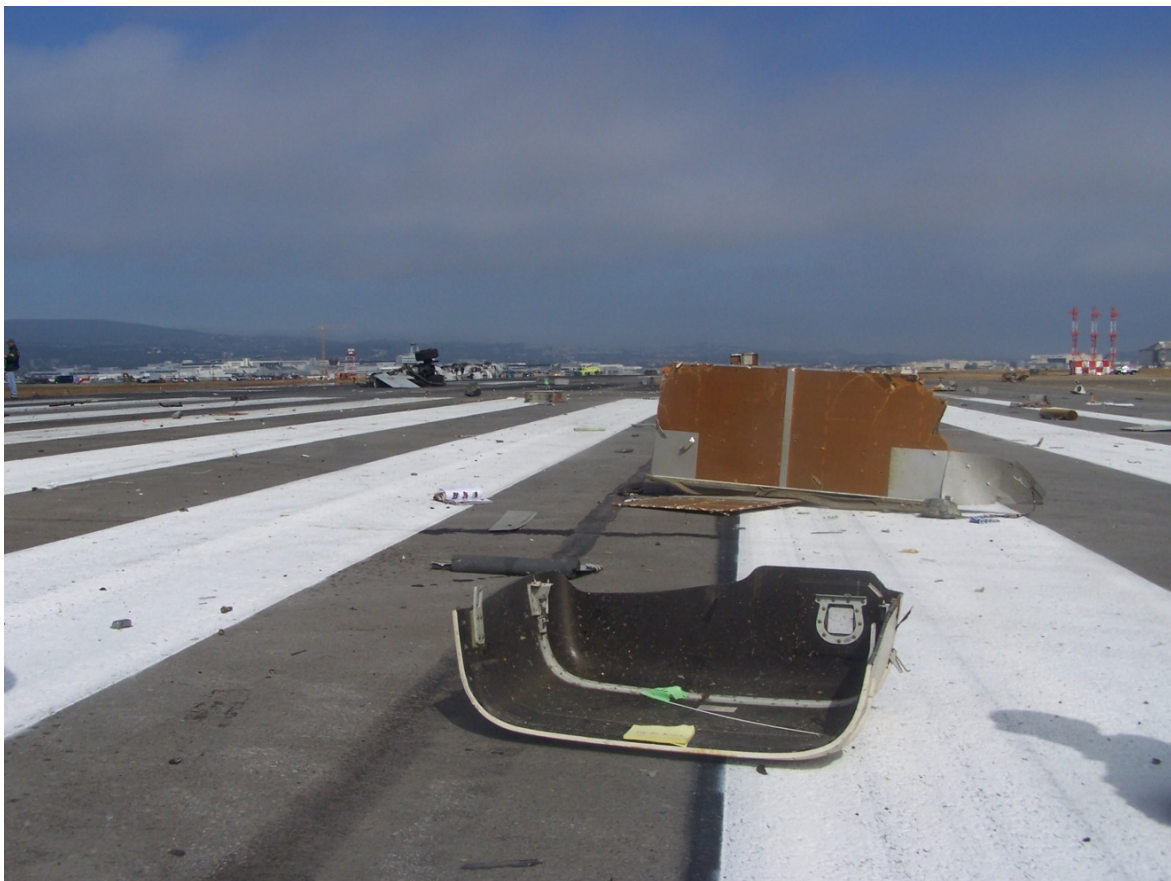
Photo 22. Door 4L slide/raft bustle and galley floor section.

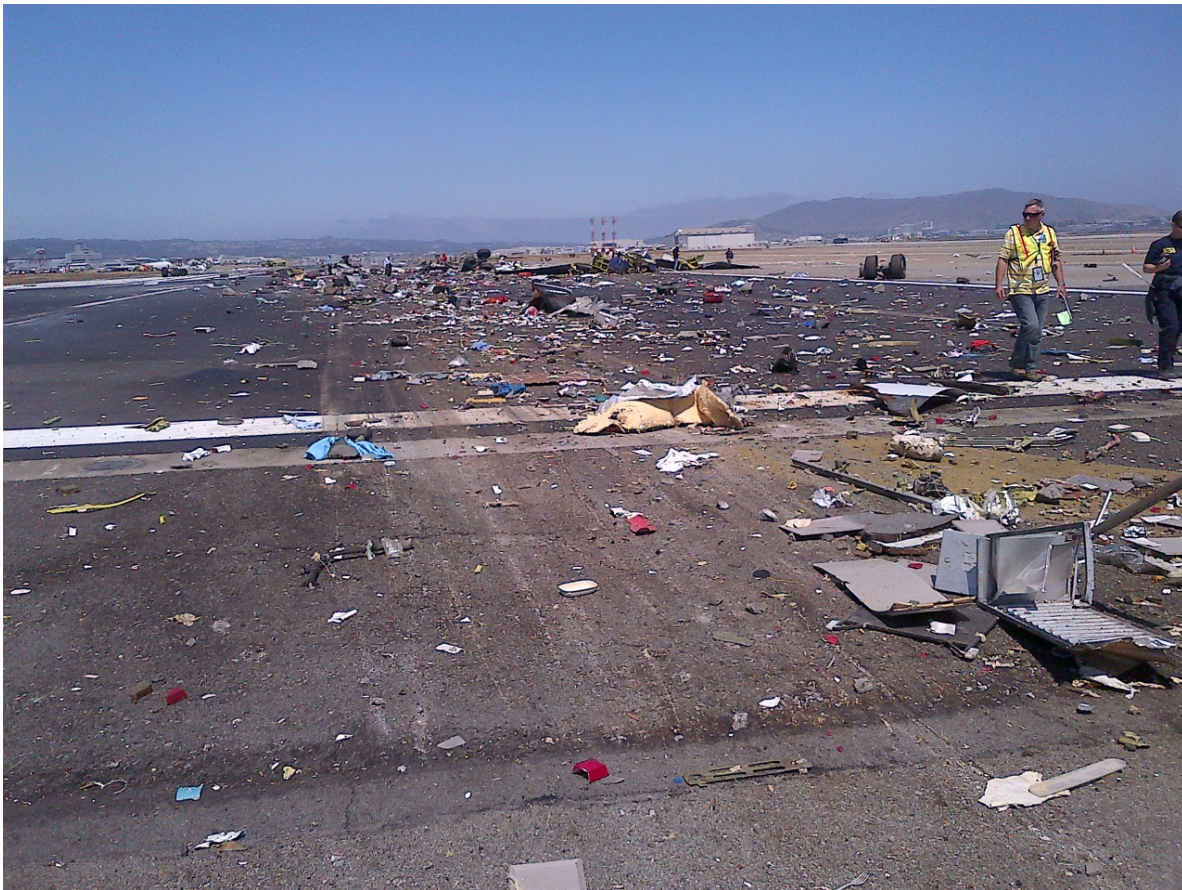
Photo 23. Debris near beginning of displaced threshold.

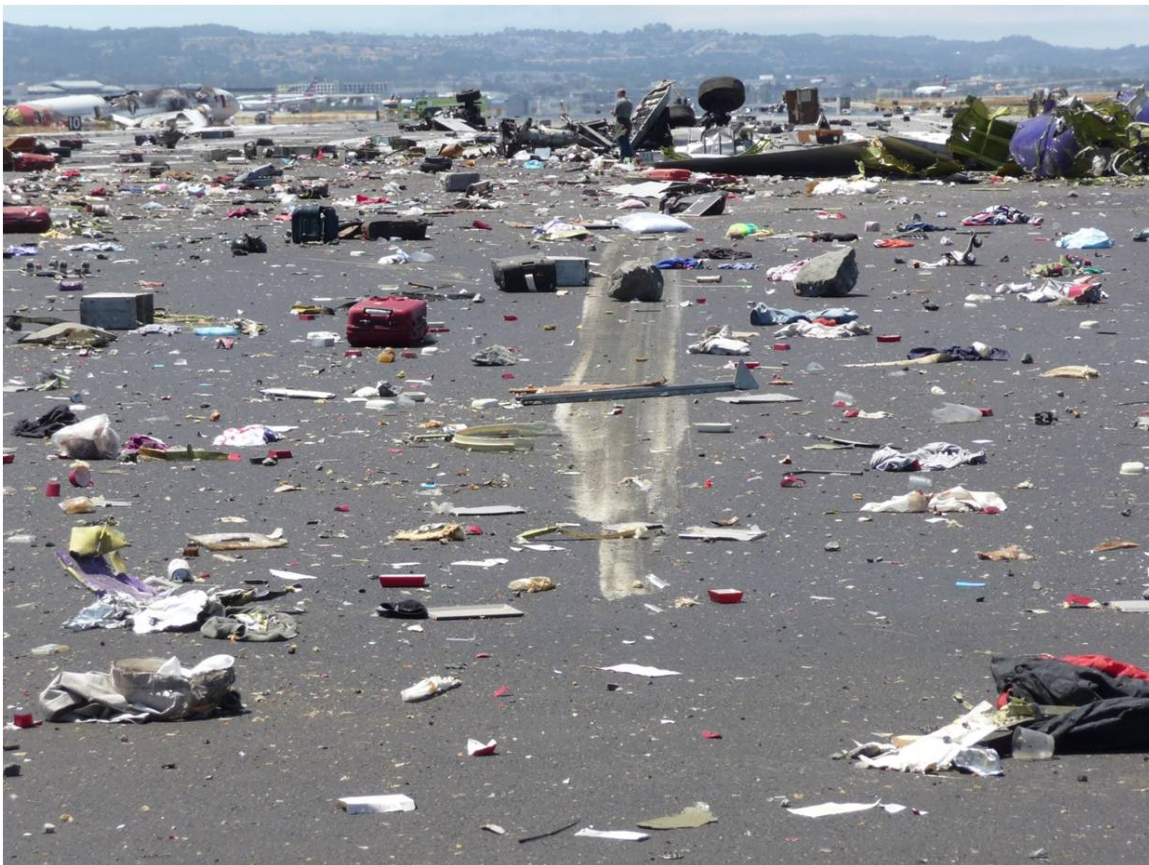
Photo 24. Debris on runway 28L.

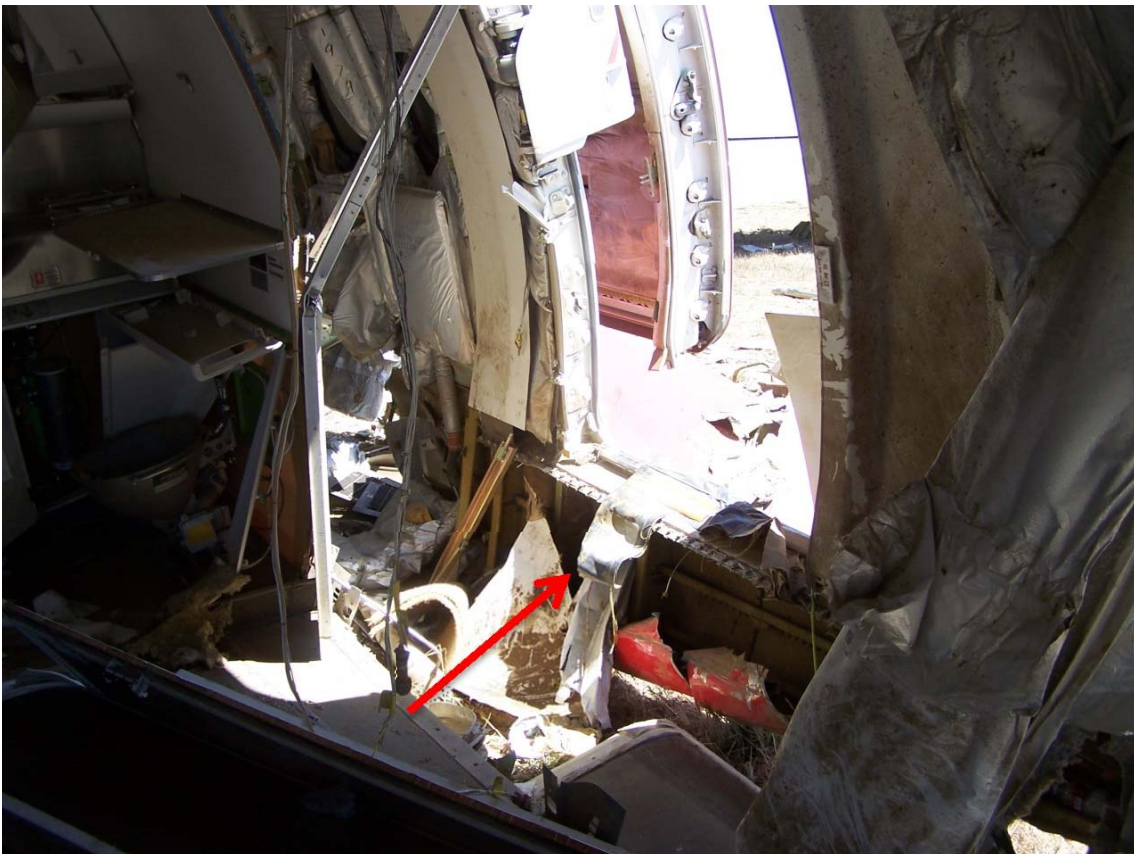
Photo 46. Door 4R slide/raft girt bar and torn girt.

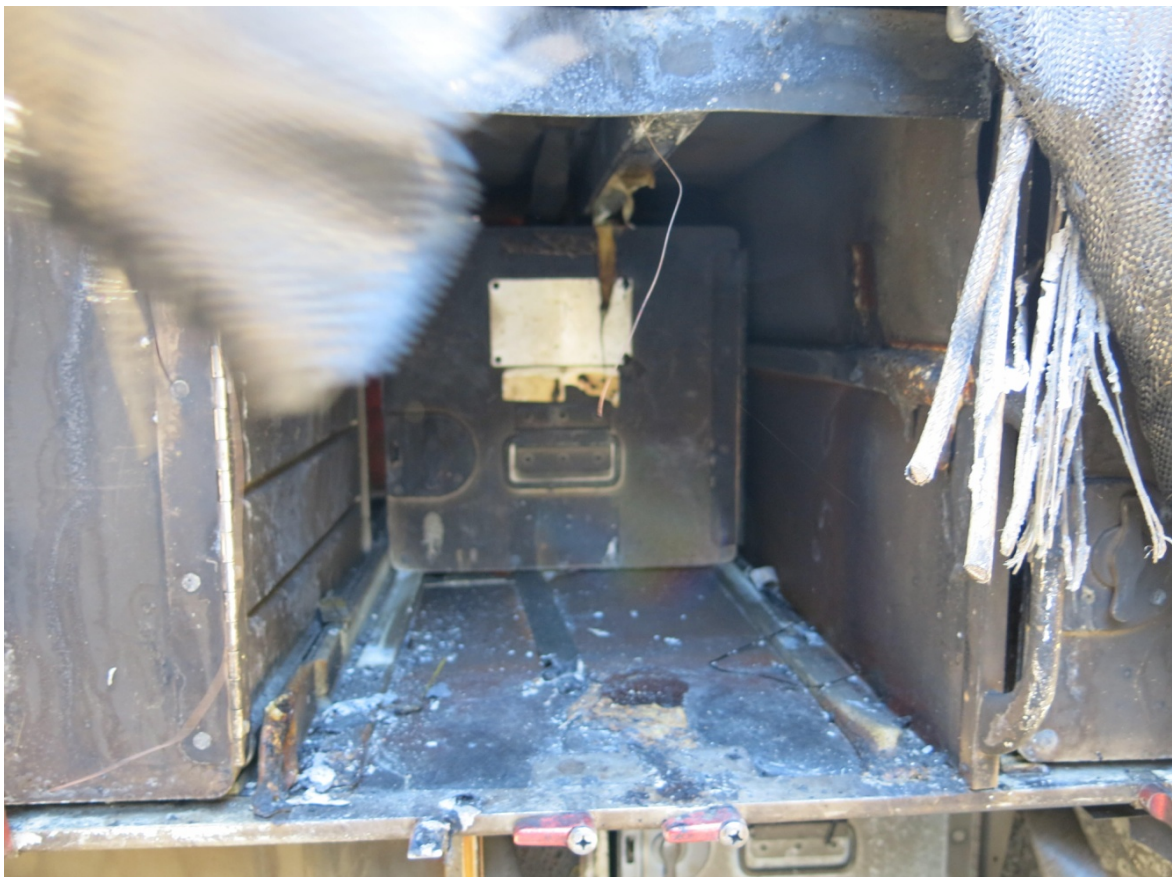
Photo 74. Location of missing galley bin in forward mid-cabin galley.

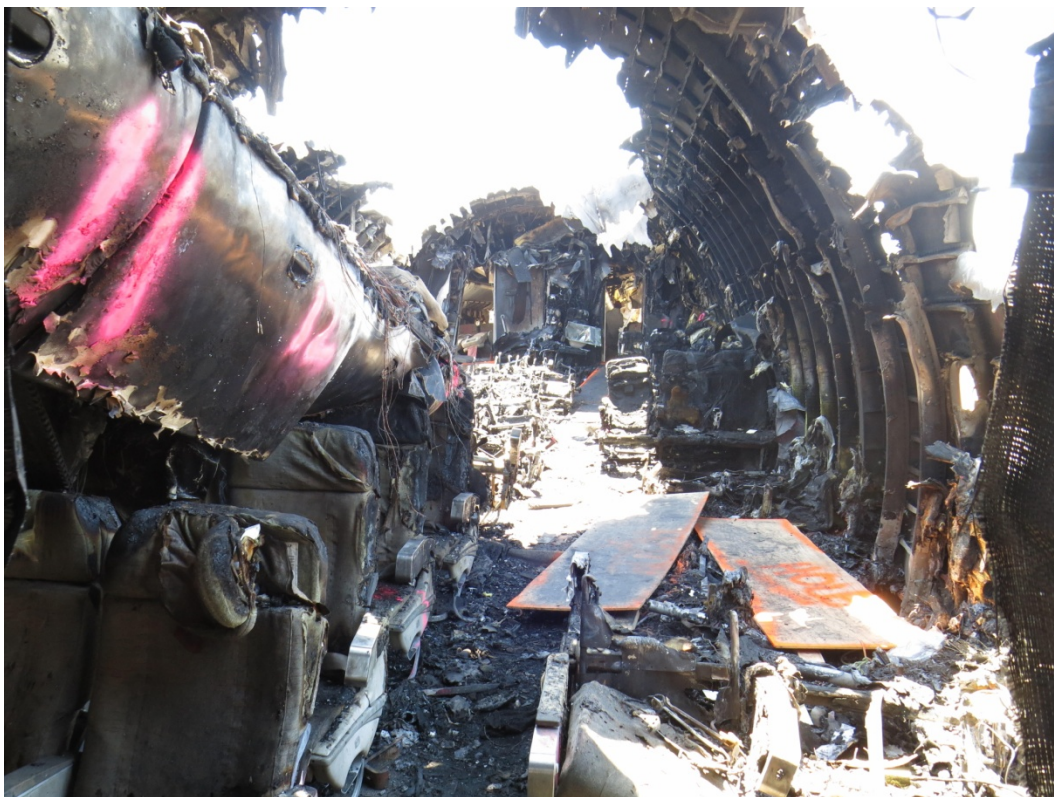
Photo 84. Aft-facing view of B-zone seats from left aisle near row 11 after debris removal.

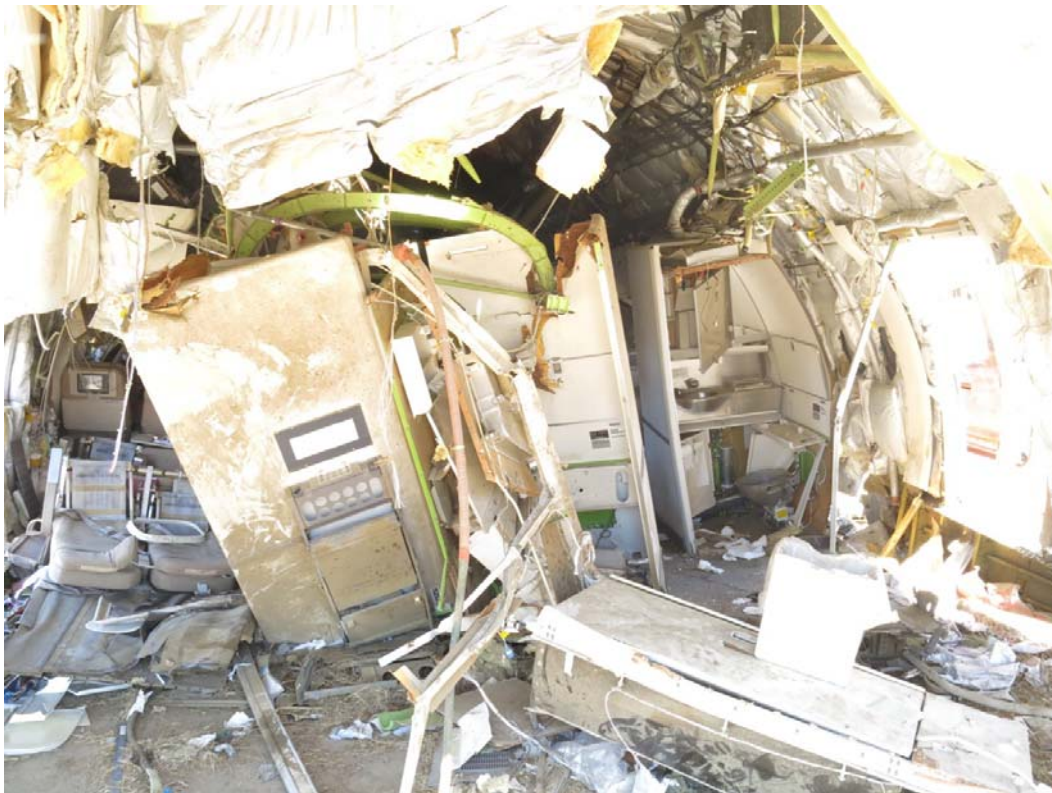
Photo 104. Forward-facing view of the aft of the airplane with debris removed.
